## Durability Consulting

### Example #1: Corrosion Engineering - Steel Pile Corrosion

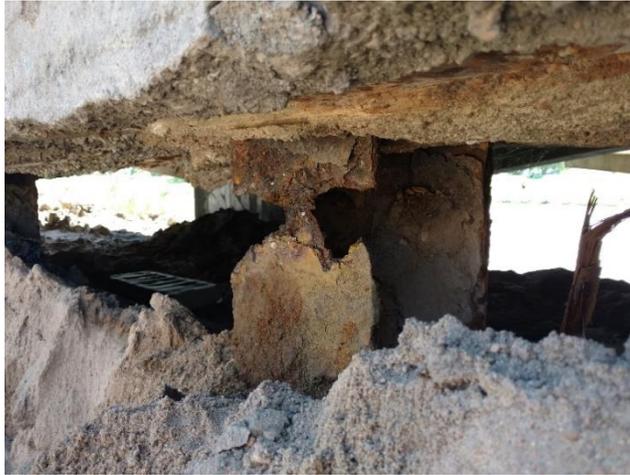
*Figure 1 – Corrosion of piles in deicing salt contaminated sand*

Figure 1 shows a photograph of a pile during demolition of the abutment, and Figure 2 shows a fragment cut off just below the abutment concrete. In this case, the piles were driven in highly resistive (>10,000 Ohm-cm), alkaline, sandy soil.

Normally, this soil environment would be considered minimally corrosive. However, one to two inches of soil subsidence below the concrete pile cap combined with contamination from deicing salt runoff produced an environment perfect for localized corrosion.

Note that corrosion reduced the pile thickness in a very localized manner resulting in perforation and buckling of the flanges. This rapid corrosion occurred in the buried portion, just below the soil line. Salt contamination acted to hold moisture in the sand just below the pile cap.

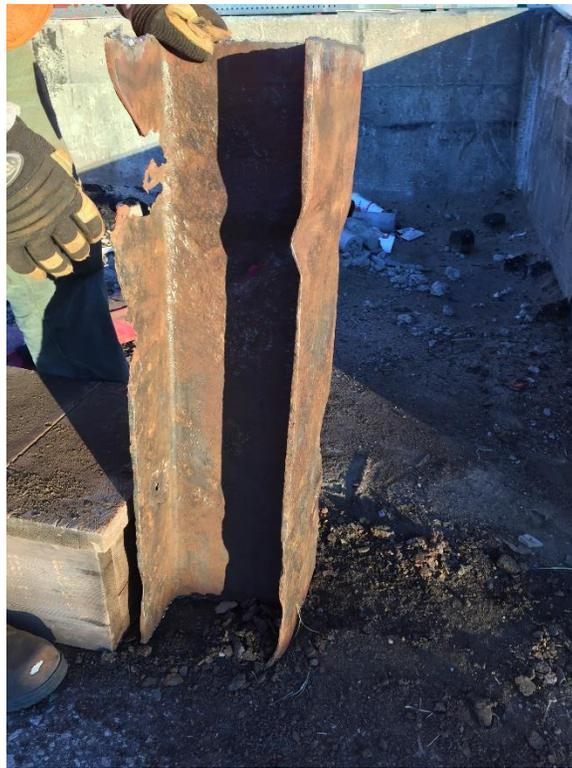
*Figure 2 – Pile fragment showing flange buckling caused by corrosion*
